# Edge-Joint Sealing as a Preventive Maintenance Practice

1. Report No. <b>MN/RC 2003-26</b>		2.		3. Recipients Accession No.	
4. Title and Subtitle <b>Edge-Joint Sealing as a Preventive Maintenance Practice</b>			5. Report Date <b>August 2003</b>

6.		
7. Author(s) <b>Roger Olson Ruth Roberson</b>			8. Performing Organization Report No.		
9. Performing Organization Name and Address <b>Minnesota Department of Transportation Office of Materials and Road Research 1400 Gervais Avenue Maplewood, MN 55109</b>			10. Project/Task/Work Unit No.

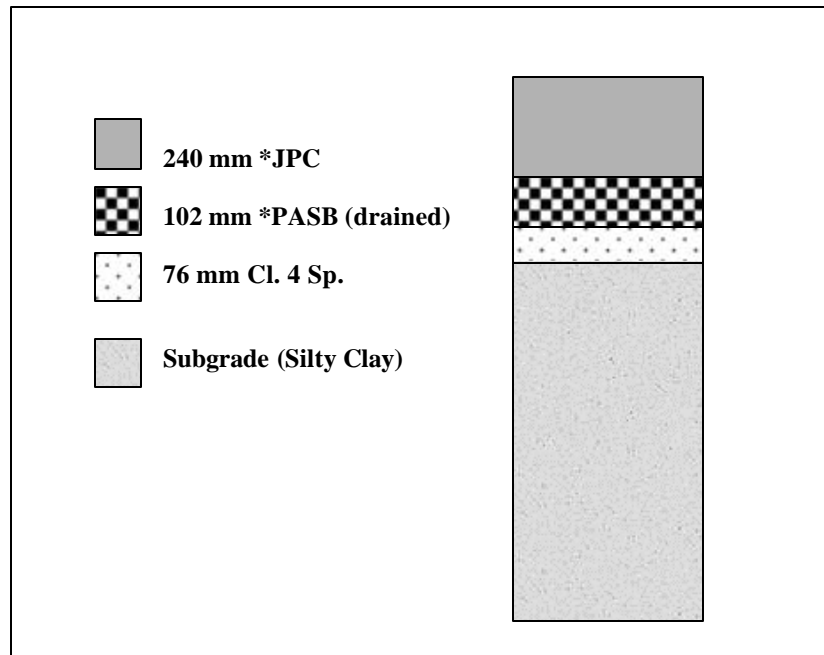
*Figure 1:* Drained concrete test section structural design. JPC = Jointed Portland Concrete, PASB = Permeable Asphalt Stabilized Base, CL. 4 Sp. is a Mn/ROAD Class 4 aggregate base material.

Five of the mainline concrete test sections were constructed with edge drains. Two similar test sections were selected for this study. Each cell was 152 meters in length with lane widths of 3.66 meters. Both test sections consisted of 240 mm of Jointed Portland Concrete (JPC) over 102 mm of a drained Permeable Aggregate Stabilized Base (PASB), overlying 76 mm of dense graded Class 4 Special granular subbase (Figure 1).

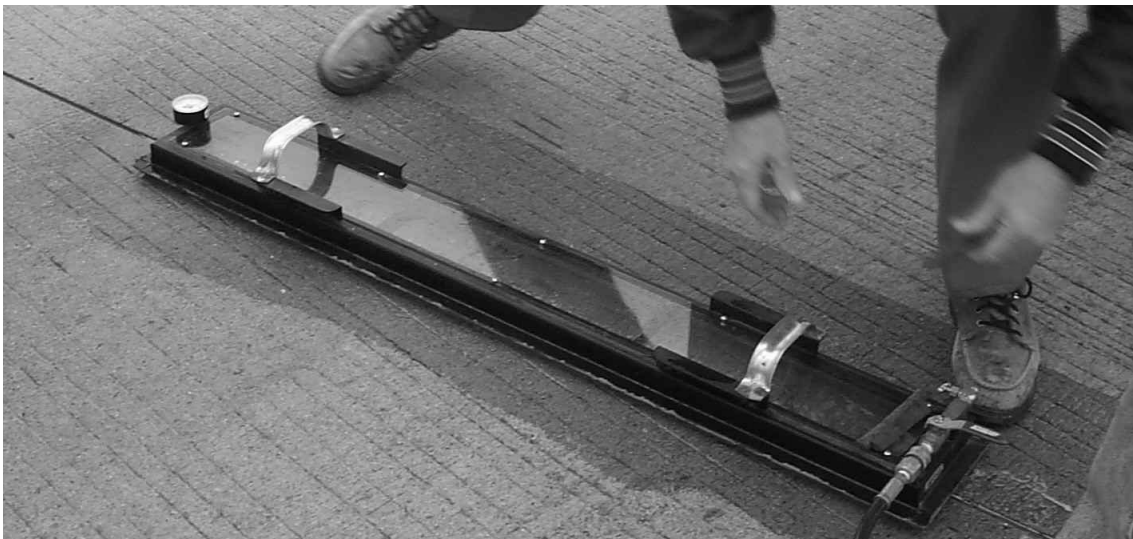
*Figure 2:* Seal testing on concrete test pavement using the IA-VAC device

Test sections consisted of random effective 15-foot joint spacing, sealed with silicone joint sealant. To test the sealant integrity, the Iowa Vacuum Joint Seal Tester (IA-VAC) device was used to test for leakage (Figure 2). The IA-VAC is an innovative vacuum joint sealant testing device that detects unseen leaks in joint seals (3). This is accomplished by spraying the joint and surrounding pavement surface with a soap/water solution, placing the chamber over the pavement surface, and applying a vacuum above the seal. Air bubbles indicate seal leakage. This device was used to test both the PCC joints and the pavement shoulder edge.

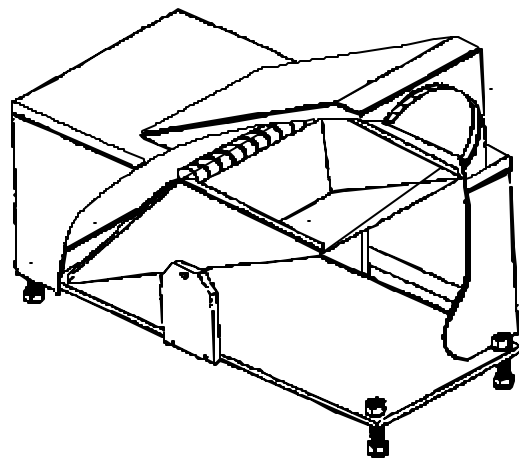
*Figure 3: Low profile tipping bucket*

Outflow from edge drains was measured by automated tipping buckets. In 1995, tipping buckets (Figures 3 and 4) were installed on drained test sections at the Mn/ROAD test facility. Test sections were constructed with longitudinal edge drains terminating at the headwall of tipping bucket enclosures. Tipping buckets provide a means for quantifying the volume of water that flows through the edge drain in response to a rain event. Flow is directed through the edge drain into the tipping bucket, resulting in a magnetic switch closure that generates an electrical pulse. Each tip of the bucket, or pulse, represents a calibrated volume of water. Each tipping bucket is wired to a datalogger that is programmed to count the number of pulses read during a 15-minute period. The data is stored on Campbell Scientific CR10X dataloggers. Data was manually downloaded to a PC on a weekly basis.

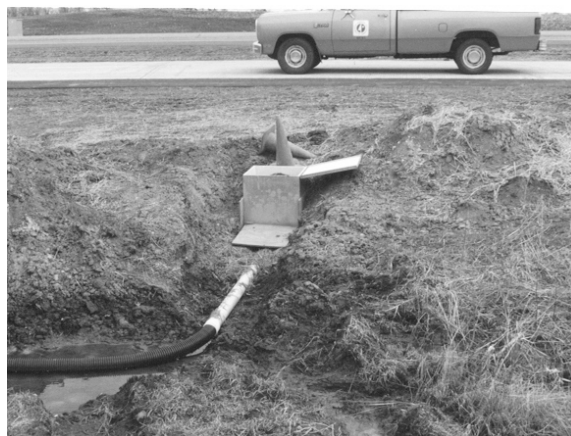
*Figure 4: Edge drain outlet and tipping bucket enclosure*

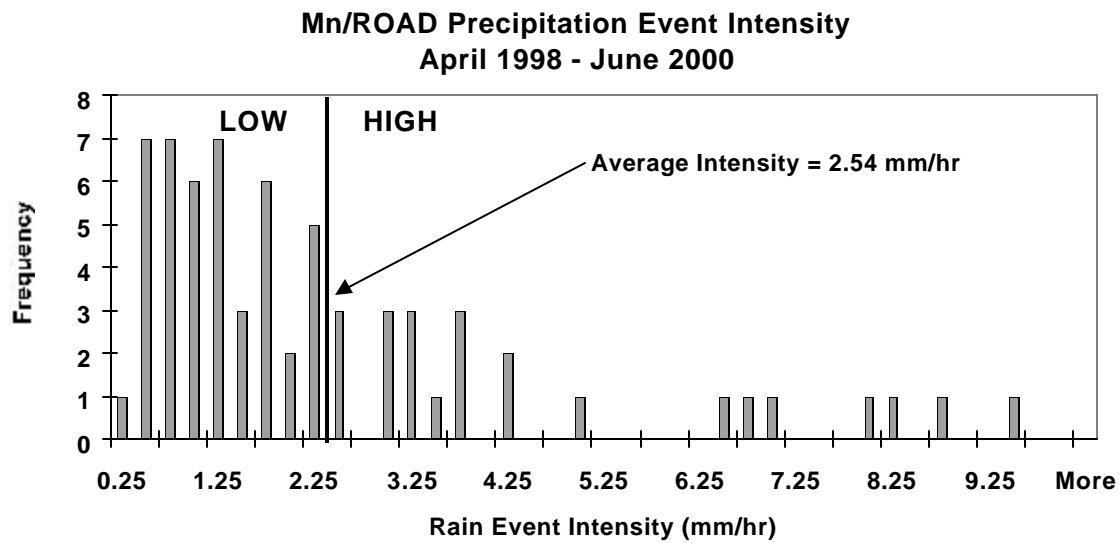
*Figure 5:* Frequency distribution of rain event intensity for the Mn/ROAD research site 1998-2000. Low < 2.54 mm/hr, High > 2.54 mm/hr.

Climatological data collected by a Campbell Scientific weather station, located at the Northwest end of the Mn/ROAD site, was used to determine rain event volume and intensity. The EPA has determined that in Minnesota the summer rainfall intensity, during an average storm, is 2.54 mm (5). Determining rain event intensity for the Mn/ROAD site was accomplished by [1] determining the event season, [2] generating frequency diagrams for the measurement seasons (1998-2000), and [3] designating LOW and HIGH intensity events based on EPA guidelines. Frequency diagrams were generated between April 1 and November 1 for the years 1998 and 1999, and April -June 2000. These time periods simplified data analysis and eliminated periods of outflow due to precipitation other than rain (Figure 5).

A plot of the frequency distributions for 1998-2000 (Figure 5) shows that the most frequent intensities for the Mn/ROAD site are in agreement with the 2.54 mm/hr average for this region. Although rarely were any events recorded at the Mn/ROAD site exactly 2.54 mm/hr., most of the events fell below or above the average. Therefore, intensities were designated as "Low" and "High" for analysis purposes.

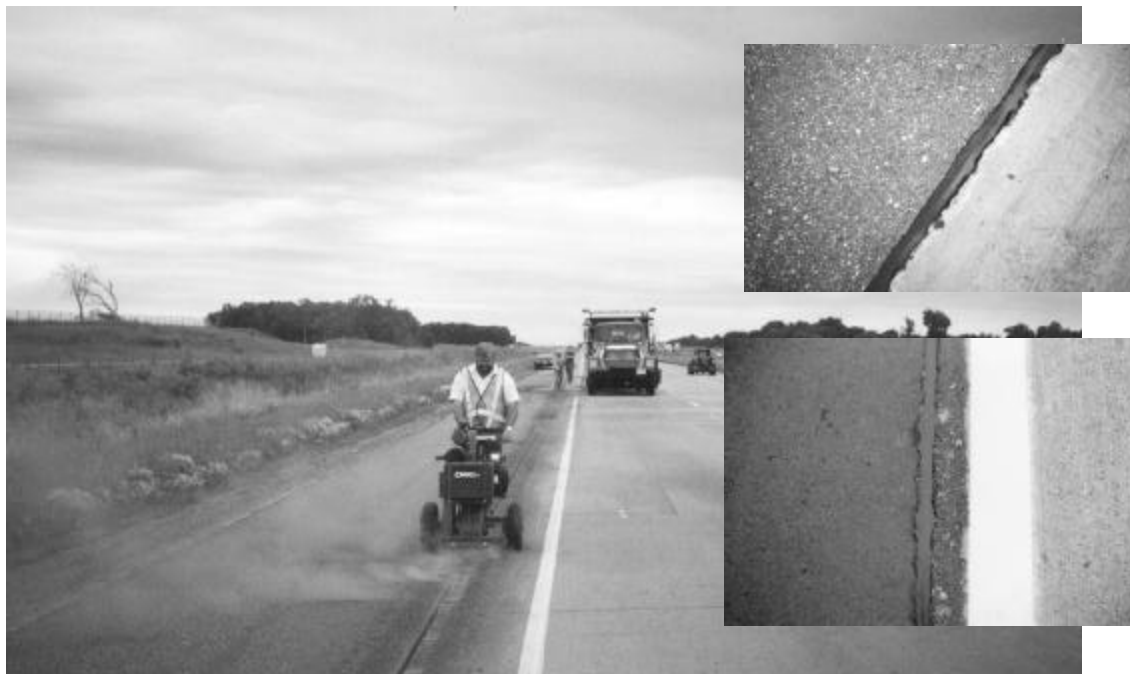
*Figure 6:* Route and Seal according to Mn/DOT Specification

Sealing the edge joint on the test section consisted of routing a 19 mm x 19 mm reservoir on the asphalt shoulder adjacent to the PCC edge (Figure 6). After clearing the reservoir of any debris, it was filled according to Mn/DOT specification 3725 with sealant. Crafcro 522 sealant was used in this study (Appendix A).

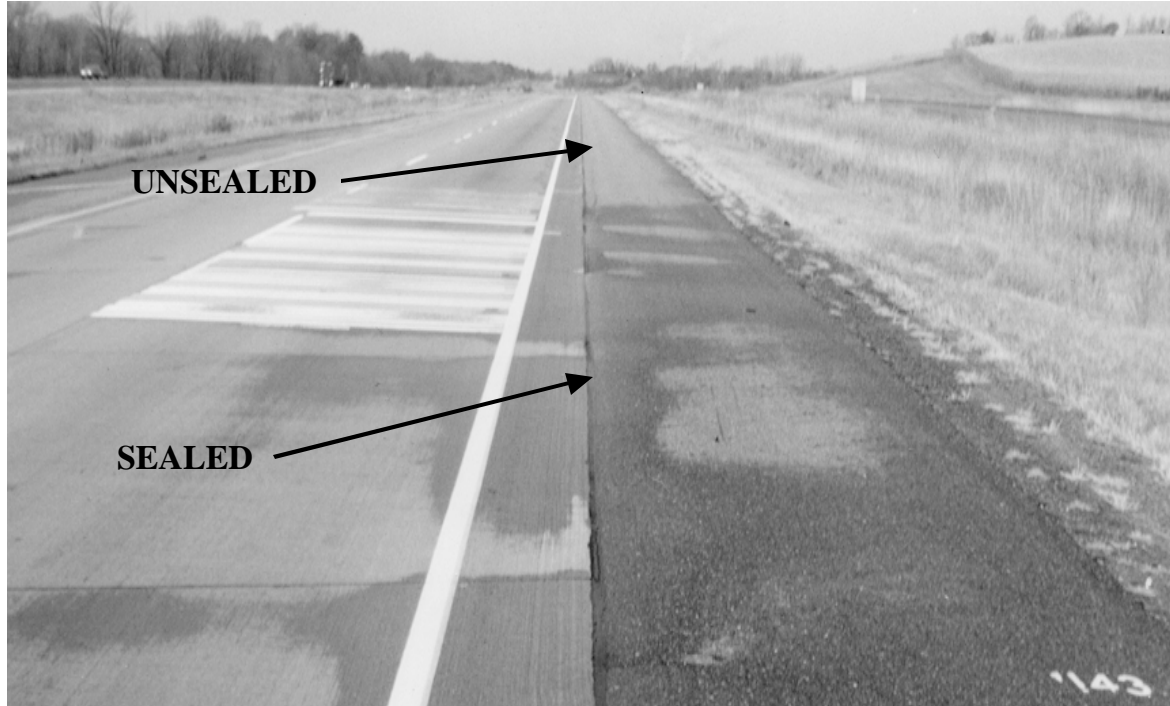
*Figure 7:* Concrete test sections after a rain event. Test section is sealed, control section is unsealed.
